Yerbilimleri, 2019, 40 (2), pp. 210-233, DOI:10.17824/yerbilimleri.533430

Non-destructive methods for determining weathering in historical monuments: a case study from Merv city, Turkmenistan

Savaş KARABULUT¹

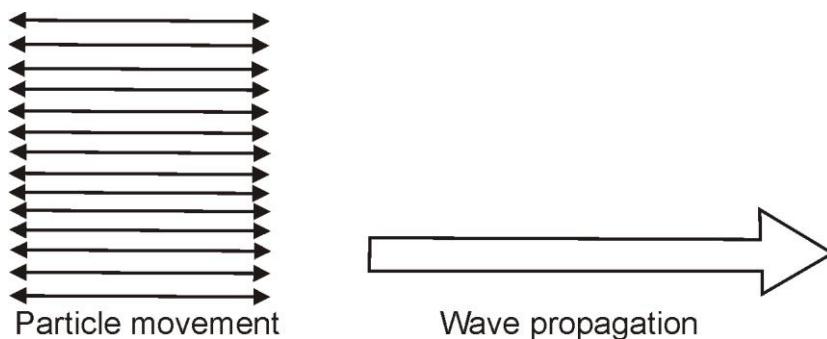
Figure 1. Particle motion and wave propagation of longitudinal waves (Mix, 2005).

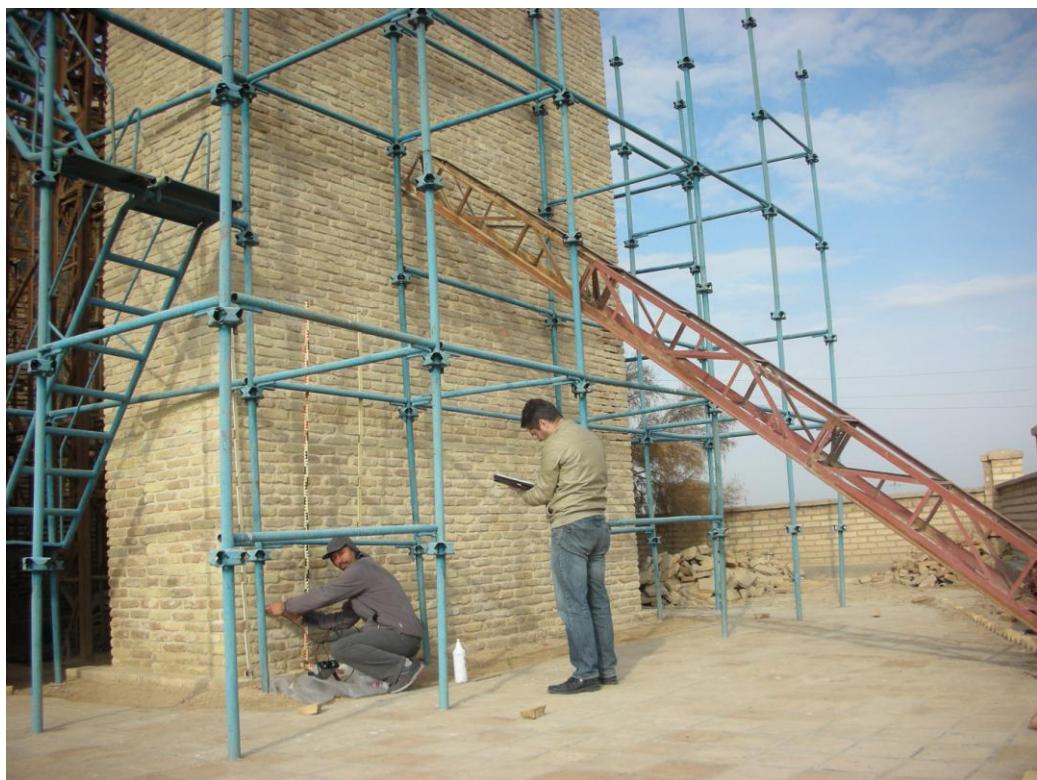
The study area consists of 2 towers and 2 mausoleums. The receiving transducers were placed every 10 or 20 cm along a measurement profile and the transmitting transducers were placed every 1 m in a horizontal direction and every 50 cm in the vertical direction. Simultaneously, ultrasonic pulse velocities and crack intervals were measured at 566 points. A view from the field study on tower walls is given in Figure 2.

Figure 2. A representative application on tower walls.

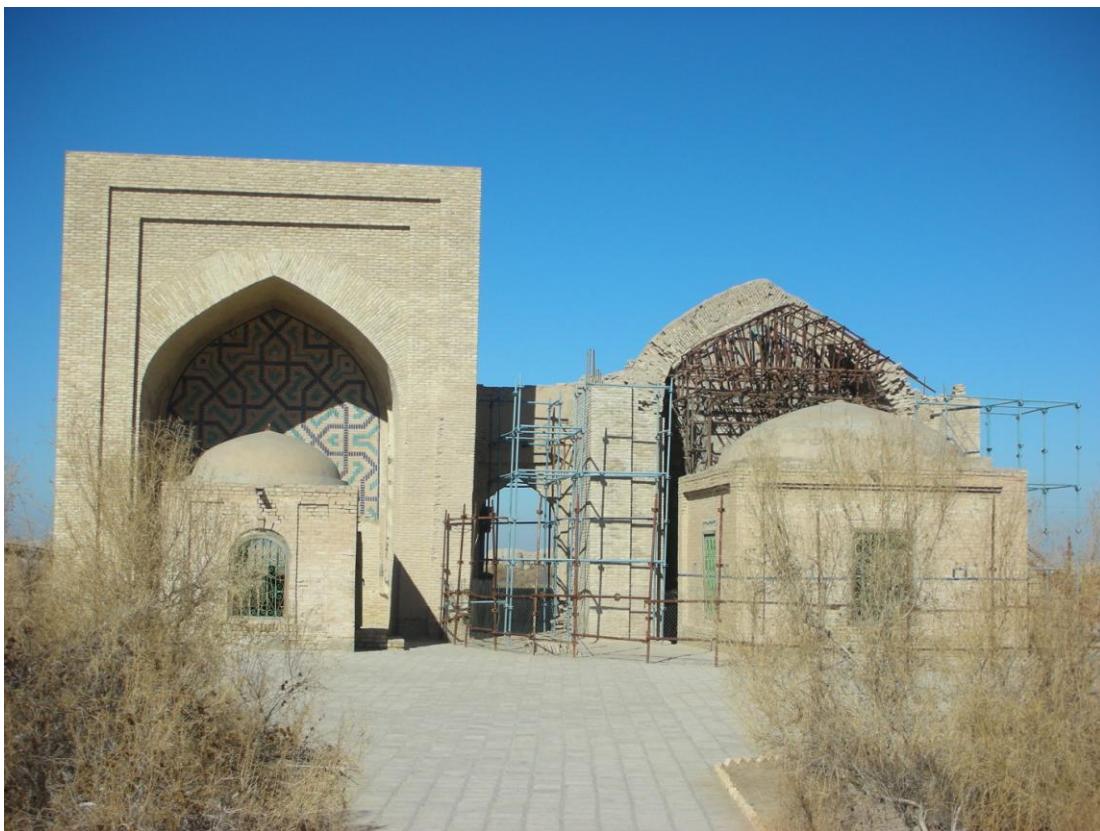
Besides remains from the Bronze and Iron ages, different historical monuments, mausoleums and mosques are preserved. The archeological site includes mausoleums of ibn Al-Khuseib al-Aslami and Al- Khakim ibn Amr Al-Gifari, from the XV century Timurid dynasty (Figure 3). Two black marbles cenotaphs mark their tombs. Behind the two mausoleums are a pair of heavily reconstructed Timurid iwans, built to honour the tombs of the Askhab. The internal walls of the latter are decorated with blue and turquoise tiles in geometric designs. In front of the Askhab complex is a water cistern that is still in use, and was built probably around the same time as the iwan. Only a shallow dome and a large arched doorway on the western

Figure 3. The archeological site in the Merv City (Turkmenistan).

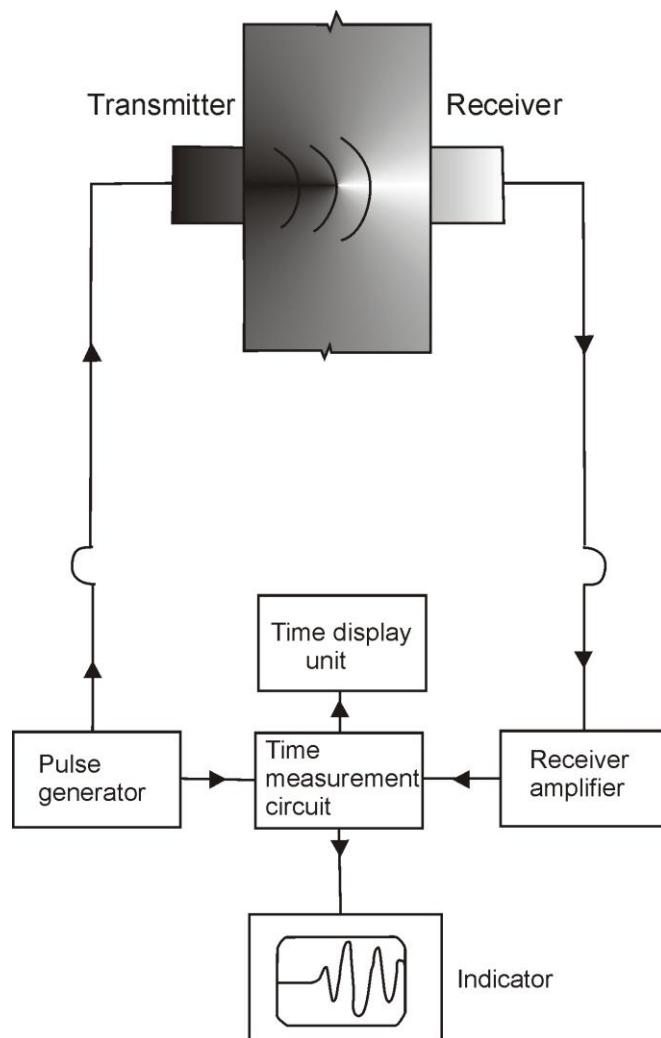
The basis of ultrasonic testing depends on the transformation of mechanical waves into electrical vibrations or vice versa. First the piezoelectric transmitters are installed. The technique is based on the principle that a pulse of longitudinal waves is induced into the concrete from the transmitting transducer (Neville and Brooks, 1997; Popovics, 1998; Meneghetti et al. 1999). Afterwards, it undergoes multiple reflections as it passes through different materials and is received and converted into electrical energy by a second transducer. The schematic diagram of a test device is shown in Figure 4. Figure 5 shows the Proceq measurement apparatus. Depending on how the transducers are arranged, the measurement type will either be defined by direct, semi-direct, or indirect methods after (Tarun et al. 2004; Figure 6).

Figure 4. Schematic diagram of the vibration speed test circuit (Tarun et al. 2004).

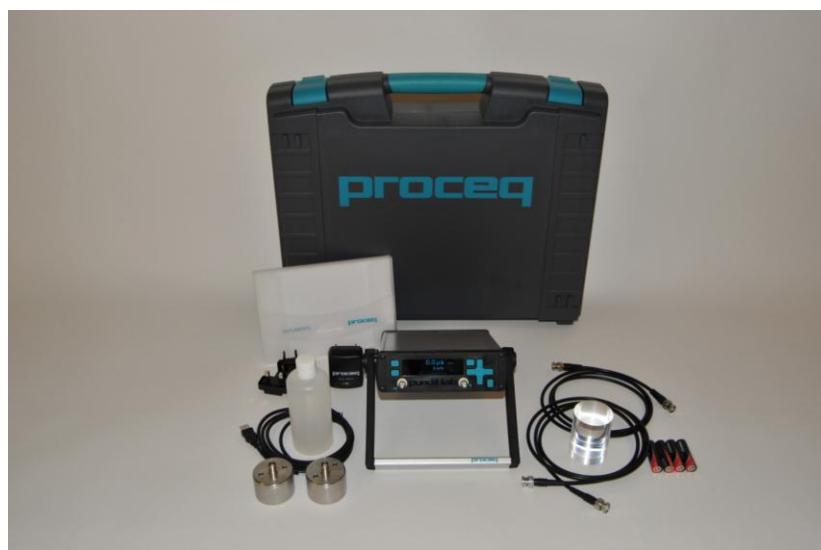
Figure 5. Measurement apparatus of Proceq Company.

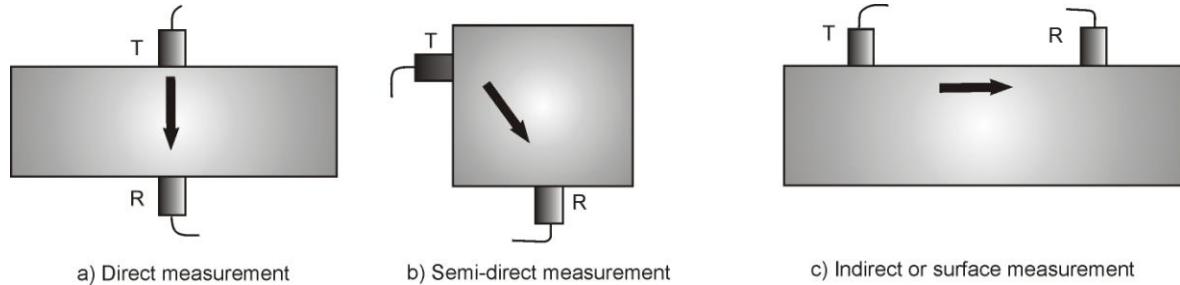
The direct measurement method was applied wherever possible to ensure the maximum signal transmission between the transducers. The semi-direct arrangement is less sensitive than the direct, but more sensitive than the indirect arrangement. The path length is the distance between the centers of each transducer. The indirect method, on the other hand, is particularly useful for determining crack depth, surface quality or in the case that only a single surface is accessible. For example, the semi-direct and indirect measurements are more effective, because they are less restrictive in transducer arrangement (Tarun et al. 2004). The velocity, v , is calculated from the distance, l , between the two transducers and the electronically measured transit time, t , of the pulse as $v = l/t$ (Figure 7). There are various

Figure 6. The vibration velocity configuration after (Tarun et al. 2004). (a) Direct method (b) semi-direct method (c) indirect method (Abbreviations: T: Transmitter, R: Receiver).

One of ultrasonic pulse velocity test that is made on the brick is determining the crack depth. This measurement can be carried out by using indirect method, in which the transmitter and receiver are put on a surface, as shown in Figure 6b. The depth to the crack can be found from the transit time (Figure 7). In this case the transmitter is placed at a suitable point on the surface and the receiver is placed on the same surface at successive positions along a specific

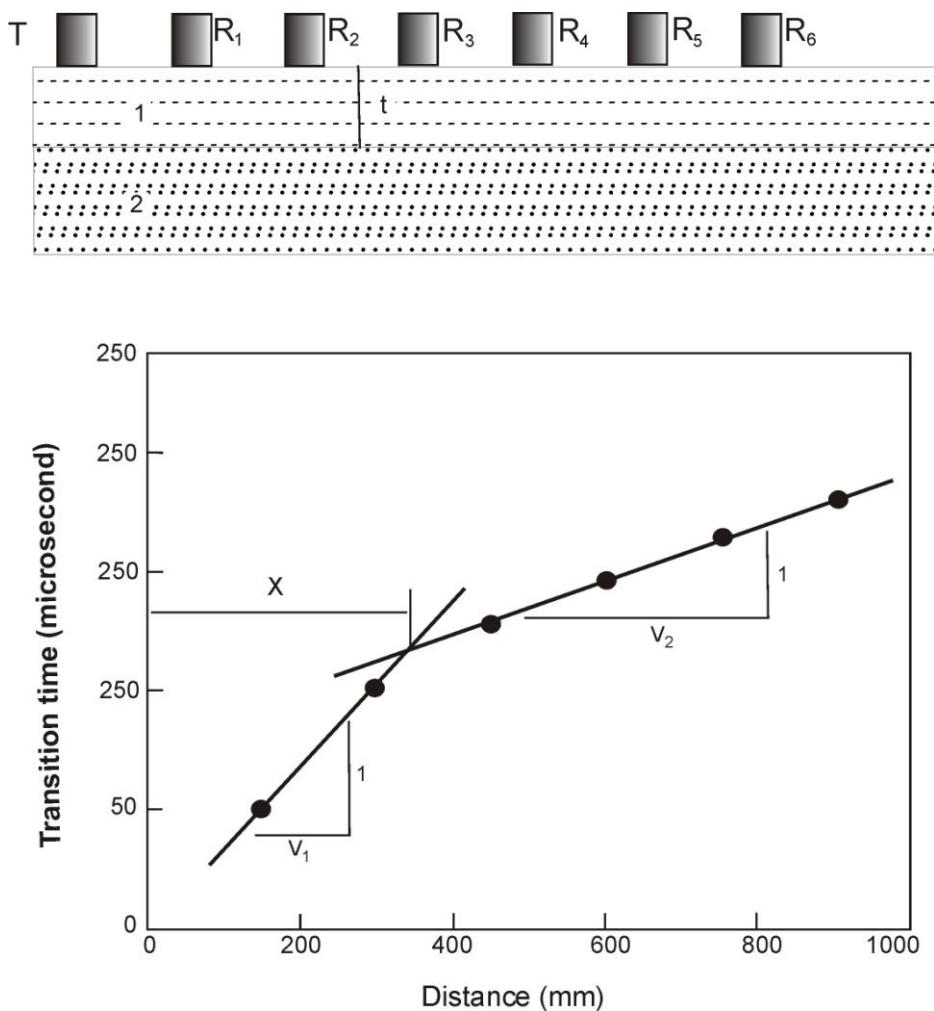
profile. The transit time is plotted in relation to the distance between the centers of the transducers, and a change in slope would indicate a change in the physical properties of the material. For example, a lower pulse velocity near the surface compared to deeper down in the material, suggests that the surface layer is weathered, and therefore of inferior quality. According to this plot, the thickness of the weathered surface layer is estimated as follows:

$$D = \frac{x_0}{2} \sqrt{(v_s - v_d)/(v_s + v_d)} \quad (1.1)$$

where V_s is the pulse velocity in the sound rock (Km/s), while V_d show the velocity in the damaged rock (Km/s). x_0 is the horizontal distance at which the change of slope occurs (mm), and D shows the depth of weathering (mm)) (Bruneau et al. 1995).

Figure 7. Indirect or surface methods for determining the depth of alteration zone (Tarun et al. 2004)
 Şekil 7 Ayışma zonunun derinliğini belirlemede Doğrusal ve Doğrusal olmayan yöntemler (Tarun ve
 diğ., 2004).

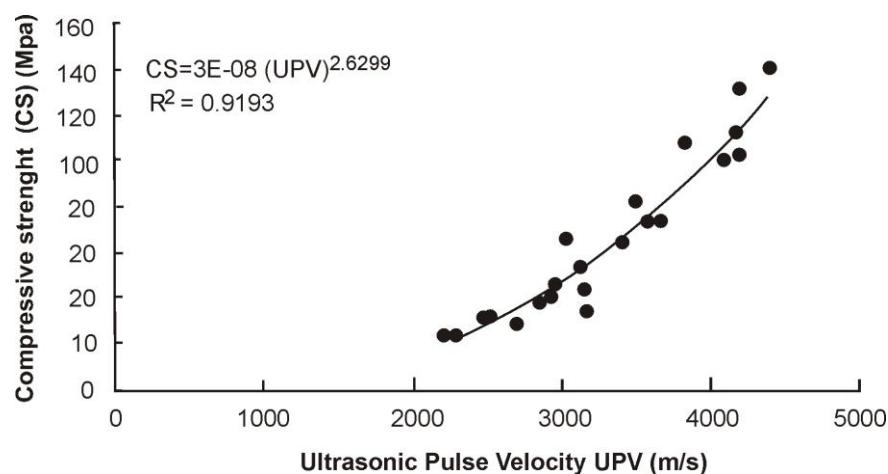
The example in Figure 8 has a regression coefficient of $R^2 = 0.9193$, which indicates a reliable relationship. The compressive strength values in this study were calculated using equation 1.3.

Figure 8. Estimating compressive strength of material using the rate of vibration (Tarun et al. 2004).

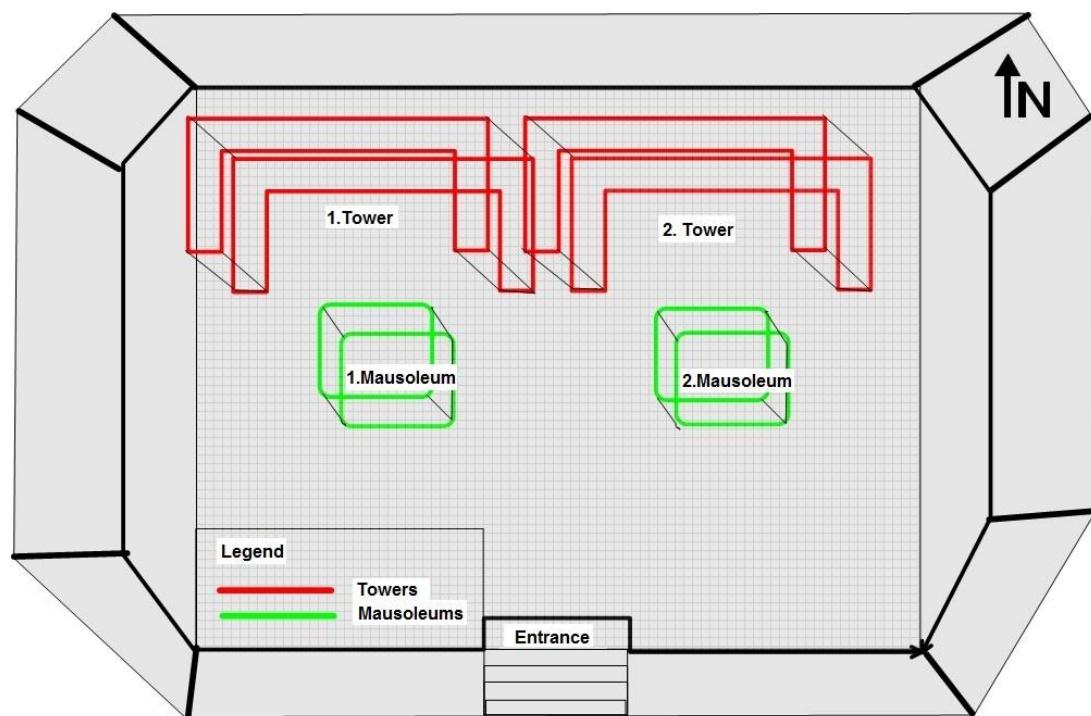
The sketch map in Figure 9 illustrates the measurement site. The two towers consist of eight walls, in which the N wall is 10 m in length, and the E and W walls are 5 m in length. Measurement could not be carried out on the N wall (surface "A"), because access was blocked by building materials for the renovation. P wave velocities were used to classify the quality of the bricks, according to the International Atomic Energy Agency (IAEA, 2002). Velocities for five walls of the tower (A, C, E, F, and G) vary between 1000-2500 m/s (Figure 10a), while velocities for walls B and H are below 1500 m/s. The systematic lower velocities on the E and W walls are thought to be due to strong northerly winds and exposure to heavy rain, which leads to higher weathering. P wave velocities are around 3000 m/s on the lower part of E and D surfaces. Overall, all surfaces fall within the classification of weak and poor (IAEA, 2002). The building elements mostly with the highest weathering are concentrated on the upper surface walls of the tower. P-wave velocities were also obtained for all eight surfaces of the second tower. The lowest velocities are found on the A and B walls, and average velocity values are < 2000 m/s. This indicates the poor quality of these two walls (Figure 10b).

Figure 9. Sketch diagram showing the present tower and mausoleum structures of the companions Al-Khuseib al-Aslami and Al-Khakim ibn Amr Al-Gifari in Merv.

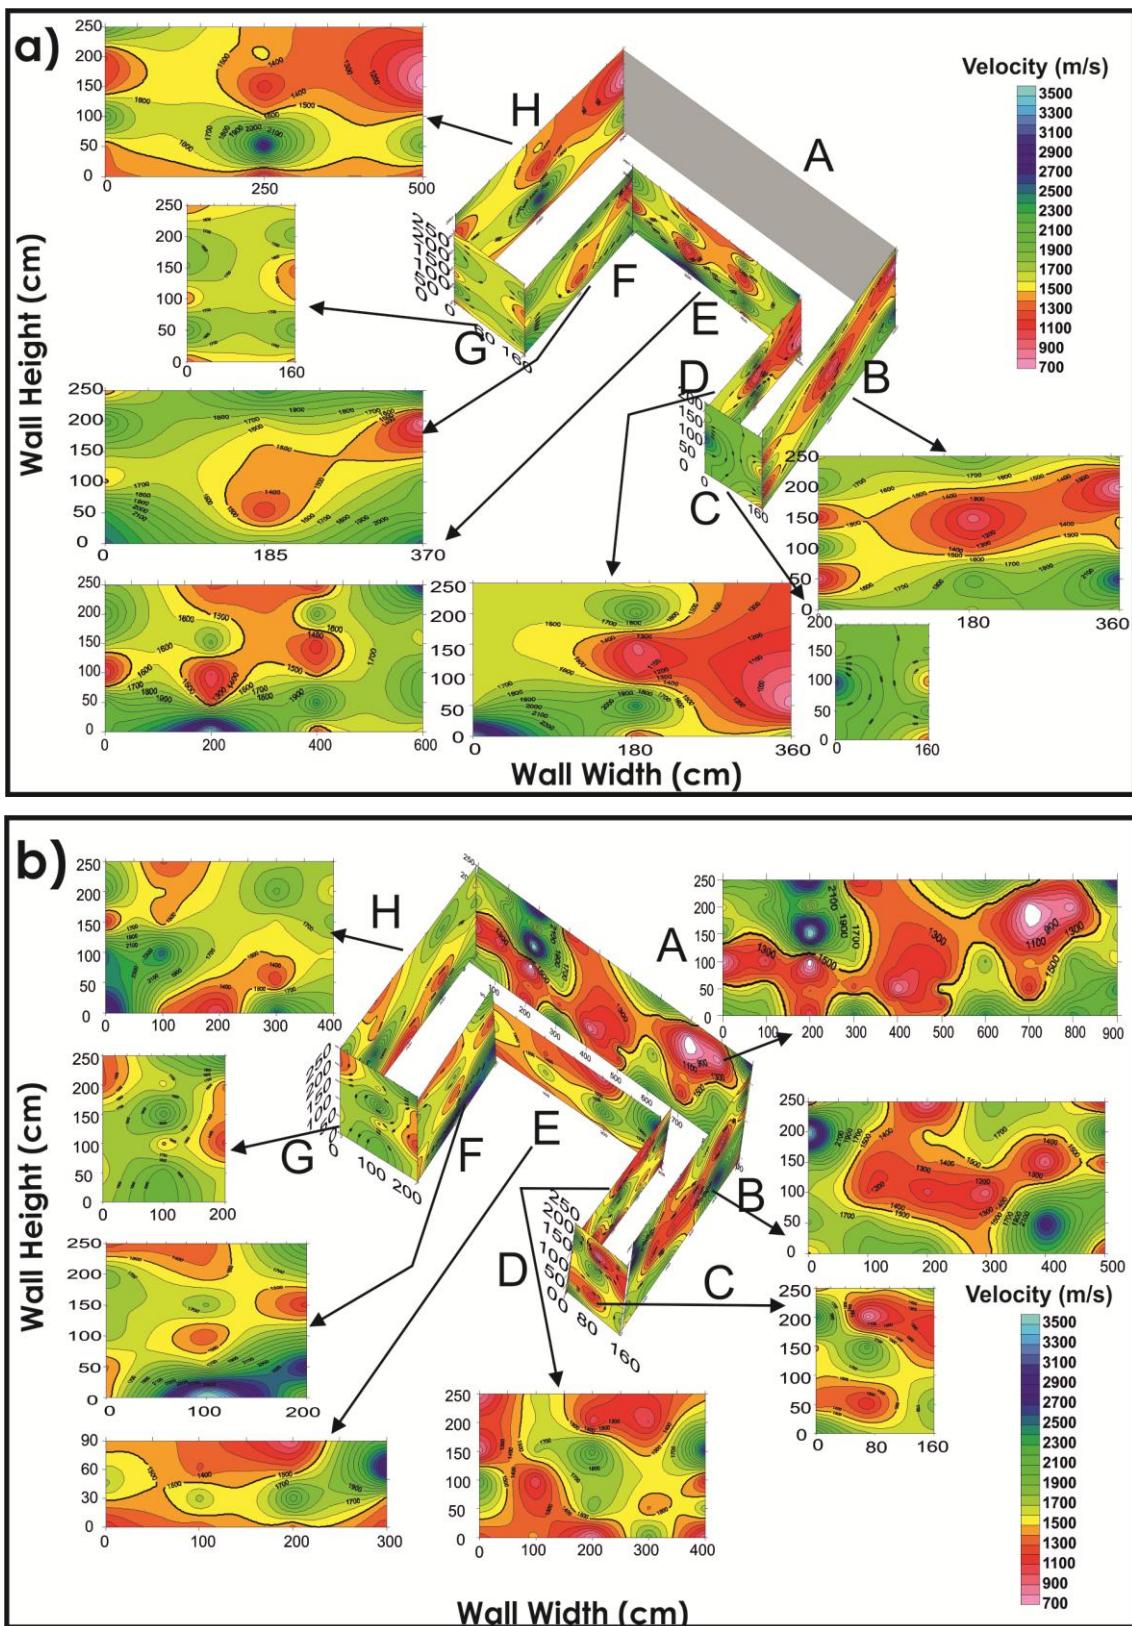
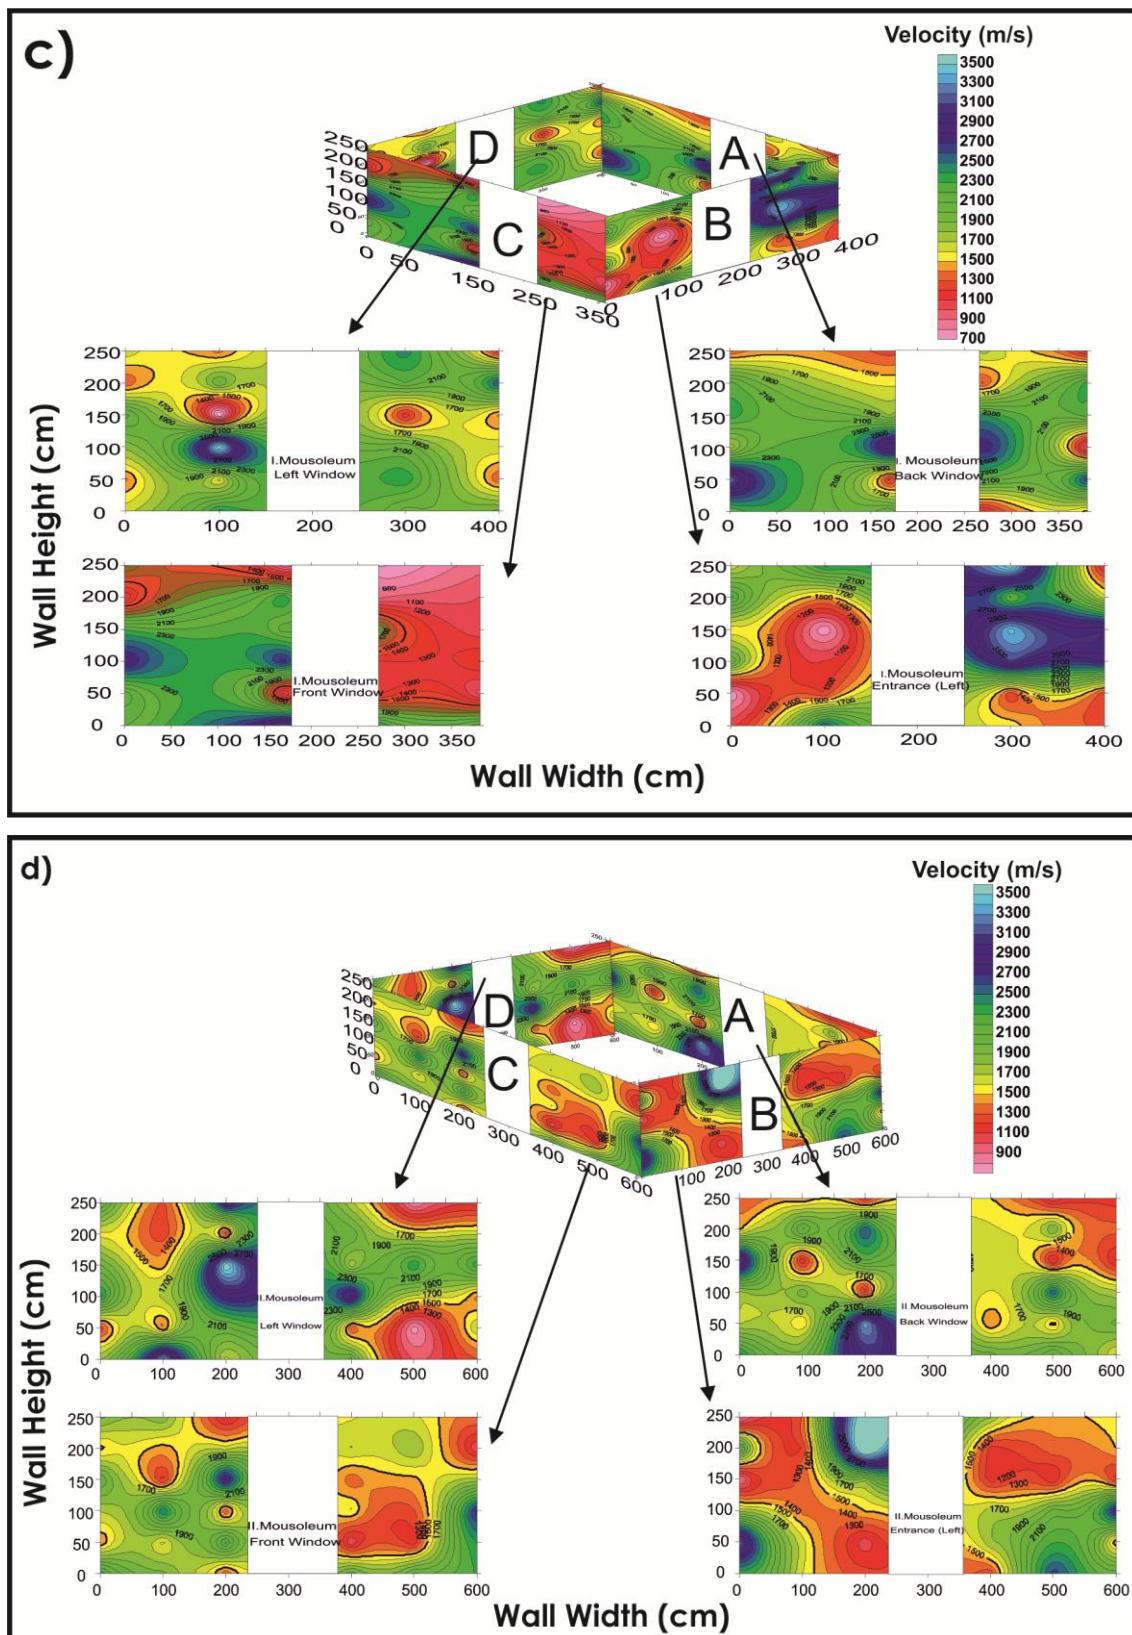
Figure 10. Velocity variation maps for the a) First tower, b) Second tower, c) First mausoleum, d) Second mausoleum.

The two mausoleums are square-shaped, and have four walls (Figure 10c and d), whereby the first mausoleum has 4m length and the second mausoleum has 6 m length. Each mausoleum has a window on each of three sides and a door entrance on the fourth side. The P-wave velocity values are < 2000 m/s and on the C and B walls of both mausoleums, and reach lower values (< 1500 m/s) in discrete areas, of higher velocity. The quality of the building material in these areas is classified as weak to poor. Velocity is especially low on the upper surfaces of the mausoleum, and also on the eastern walls. These differences are thought not be the result of climatic conditions, but may have occurred during construction. The overall low P-wave velocities in both mausoleums, and strong gradients between poor to medium suggest poor workmanship during the construction. Climate conditions, however, may have caused weathering and deformation in different parts of the mausoleums.

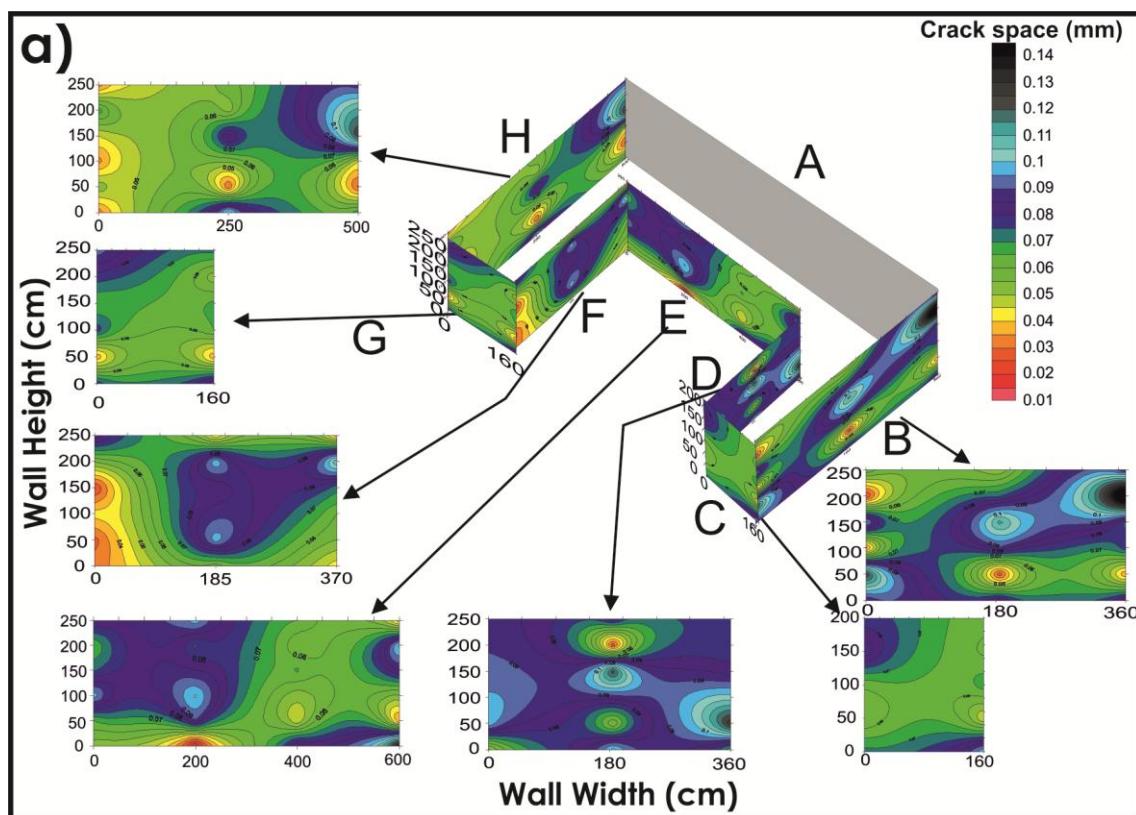
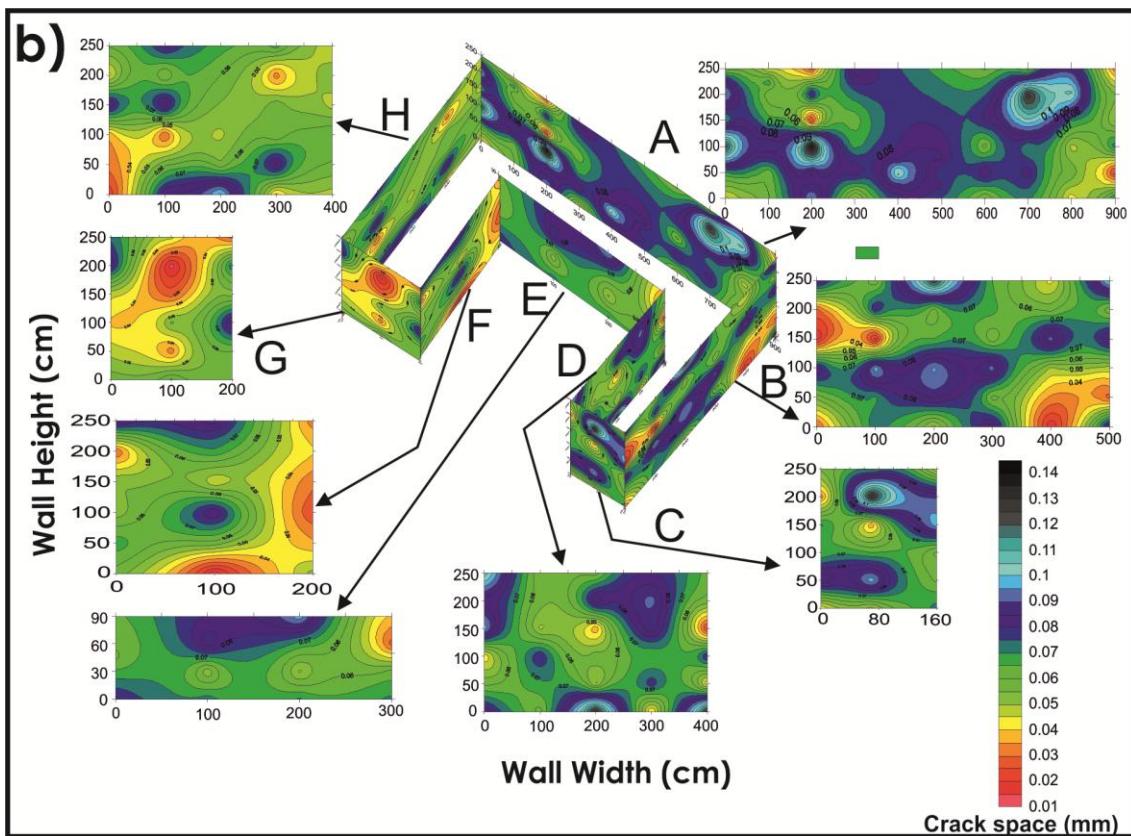
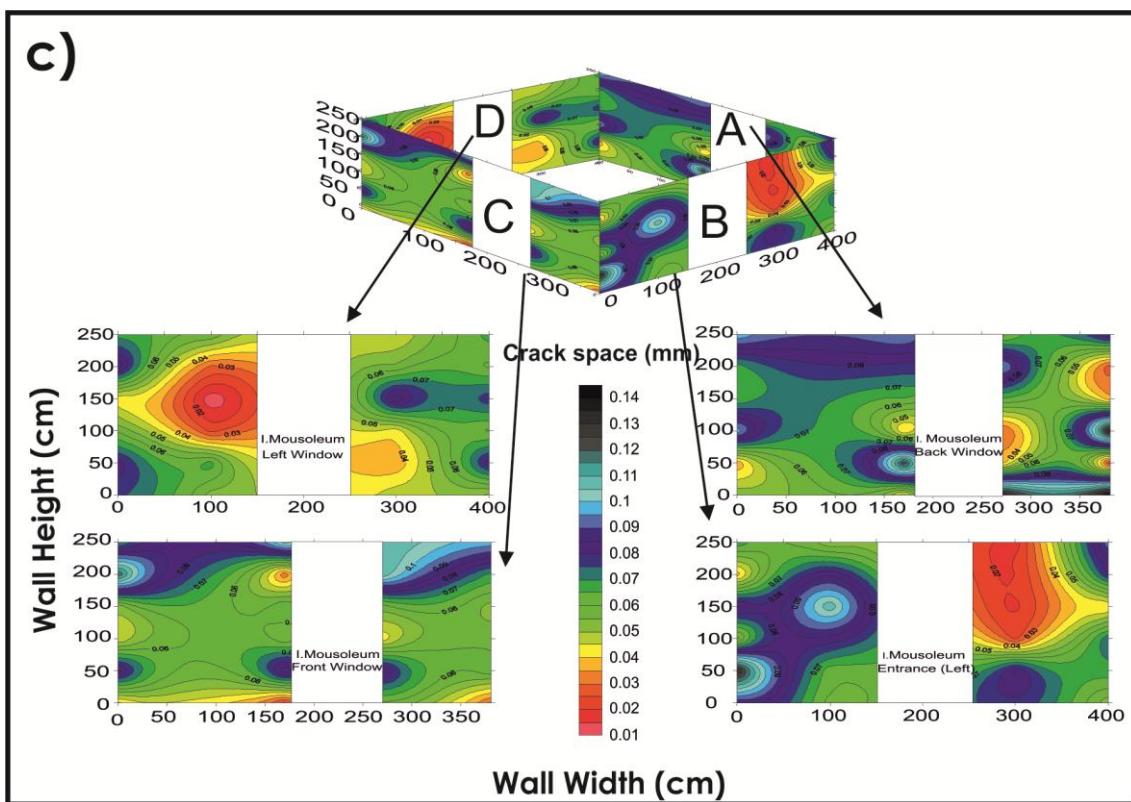
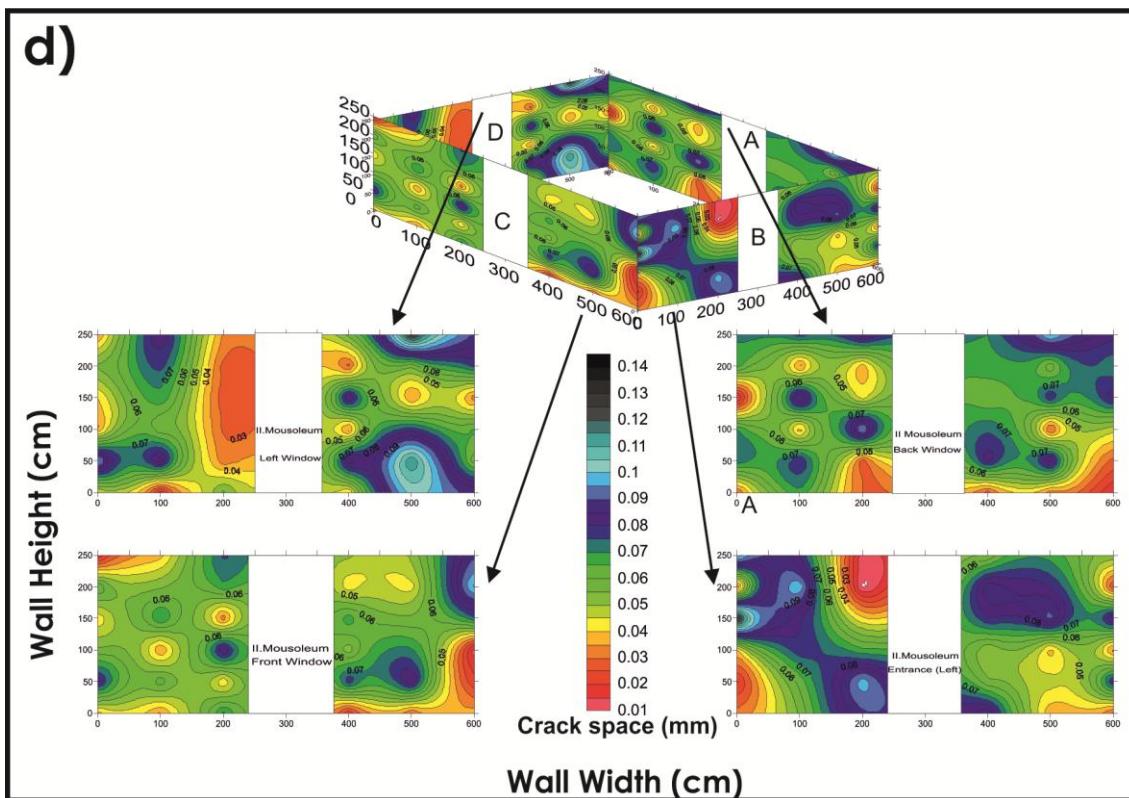
Crack-depth measurements were taken approximately every 10 cm, so that both the transmitter and receiver sequence is on the brick for Tower 1 (Figure 11a). All crack depths, which are calculated from the P-wave velocities, range between 0.05 - 0.1 mm. Note that these measurements are not due to cracks but fillings in these cracks.

Figure 11. Crack space maps on a) First tower walls, b) Second tower walls, c) First mausoleum walls, d) Second mausoleum walls.

The crack depth obtained on the outer surface of the tower 1 show a crack classification of II. degree (Table 2). Although there are similar crack depths in Tower 2, diagonal variation on walls B, F, G and H are small when compared to the other walls, and crack depth that varies between 0.01-0.05 mm (Figure 11b). This tower is defined as II and III crack classification degree. When compared with the P-wave velocity values it is shown that the P-wave velocities increase relative in the same areas and the brick quality shows a medium degree.

Because bricks and joints show similar structural properties, it is suggested that the differences in the opening can develop due to time and atmospheric conditions. The difference in the classification between Towers 1 and 2 depends not only on wind direction and rainfall, but also on physical factors from the west. The crack openings observed in the Mausoleum 1 are about 0.1 mm, while on the left window and the right surface of the door are 0.01 mm. In the Mausoleum 2, however, a randomly increase or decrease is observed in many areas. The cracks are classified as II and III degree (Table 2), similar to the crack classification for the towers, which suggests that wind and precipitation from the

north and west are effective in weathering. Since the domes on the mausoleums are under structural pressure, the tensional force that may occur in the dome can lead to cracks in the vertical direction. Thus resulting damage or deep cracks on the bricks which are beneath the dome, indicates that the bricks need to be renewed because of the decrease on their rigidity.

Some walls should be protected with higher strength materials when compared to others. It should be noted that any restoration of this archeological site should benefit the results of this study. It is of great importance whether to use the appropriate material for a long time resistance with minor financial loss.

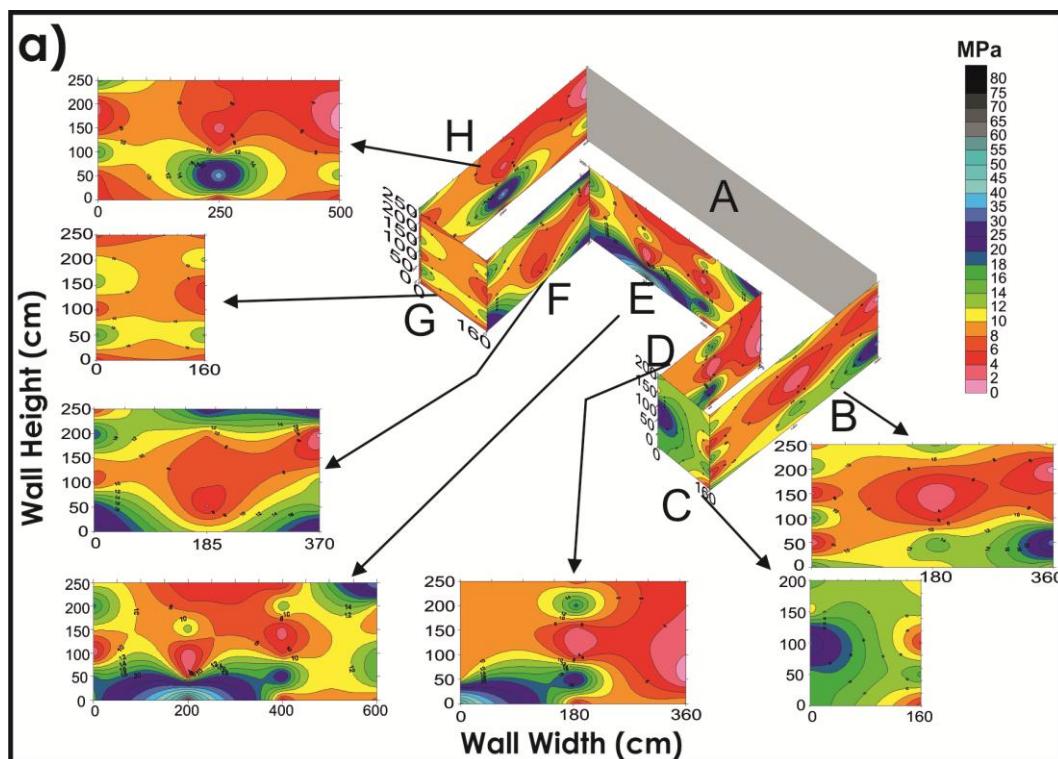
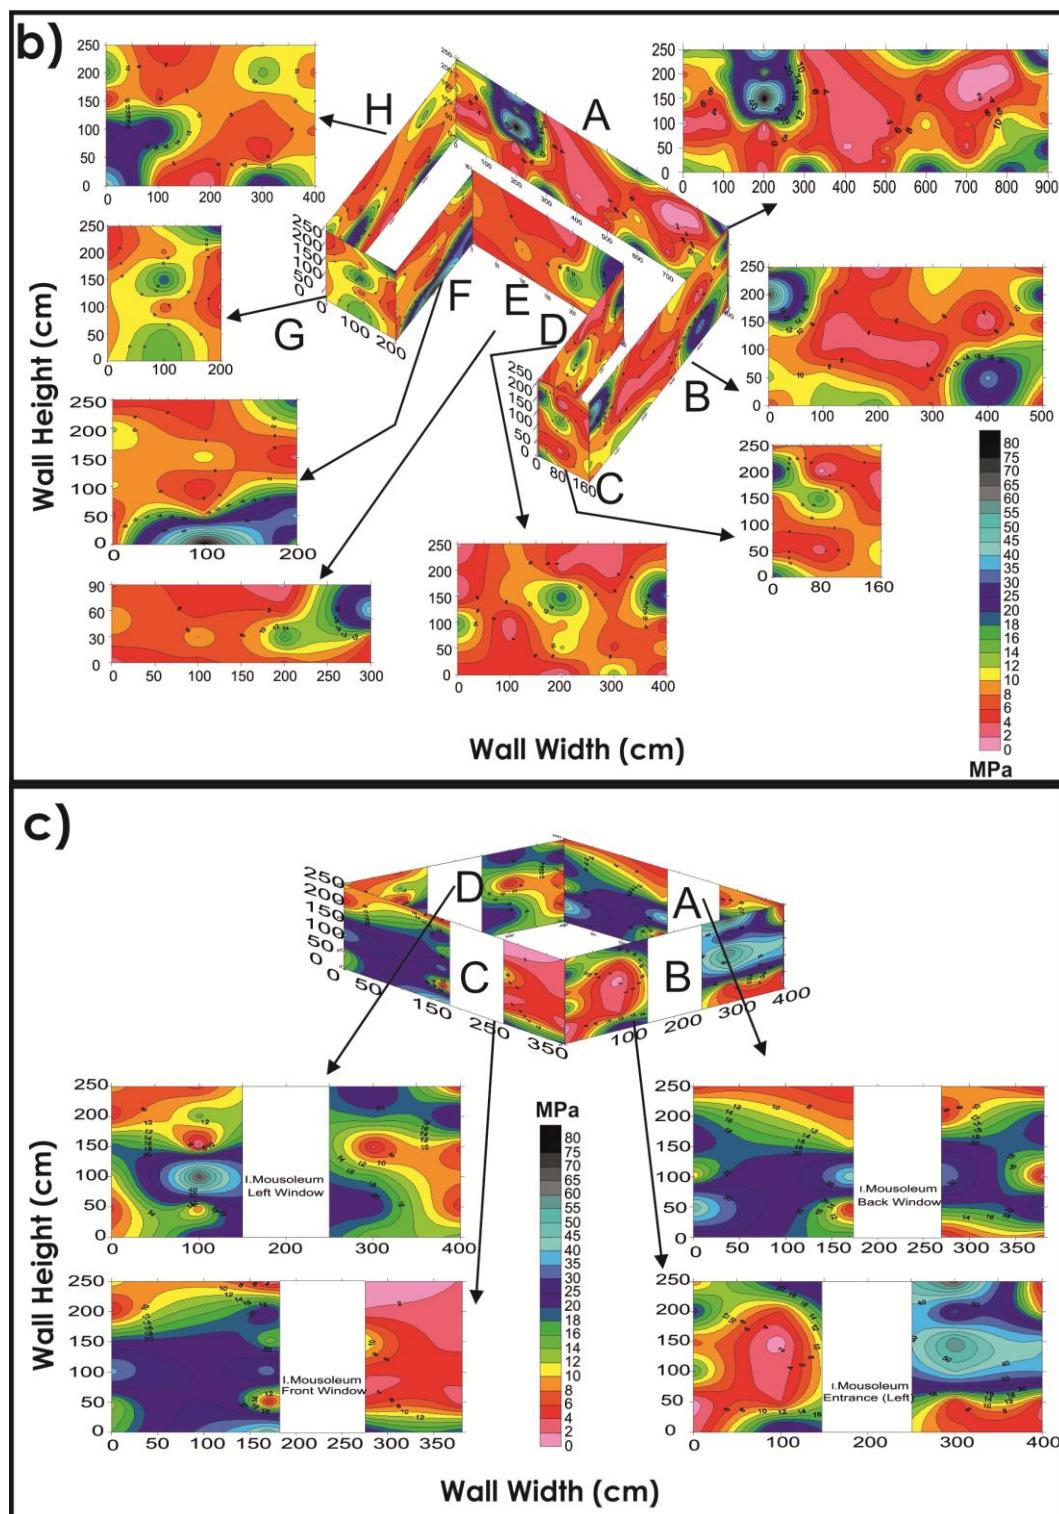
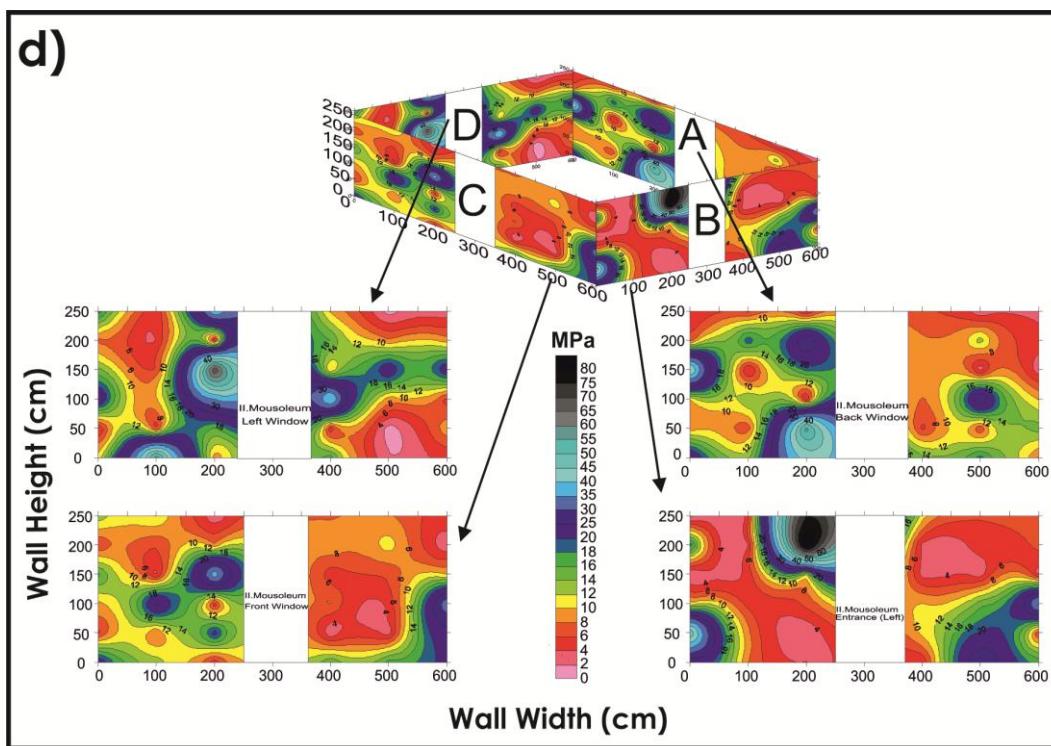
The compressive strength of the structural elements was calculated and mapped using the velocity values given in Figure 10 to show the resistance of existing structures and structural systems before the renovation process (Figure 12). Bricks in the Towers 1 and 2 show compressive strength of 2-8 MPa (Figure 12 a and b). In the mausoleums, the compressive strength were relatively higher while building materials show a compressive strength of 20-30 MPa on four sides of the Mausoleum 1 with a similar result for Mausoleum 2 (Figure 12 c and d).

While structures were destroyed partially by various invasions, renovations that led to reinforcement of the structures were not homogenous. In addition, strong winds blowing from the northwest in the spring and autumn were effective eroding different edges of the structures.

Figure 12. Variation of compressive strength maps a) First tower walls, b) Second tower walls, c) First mausoleum walls, d) Second mausoleum walls.
